The Sizewell C Project

9.64/ Draft Fen Meadow Plan - Clean
10.6 Version

October 2021

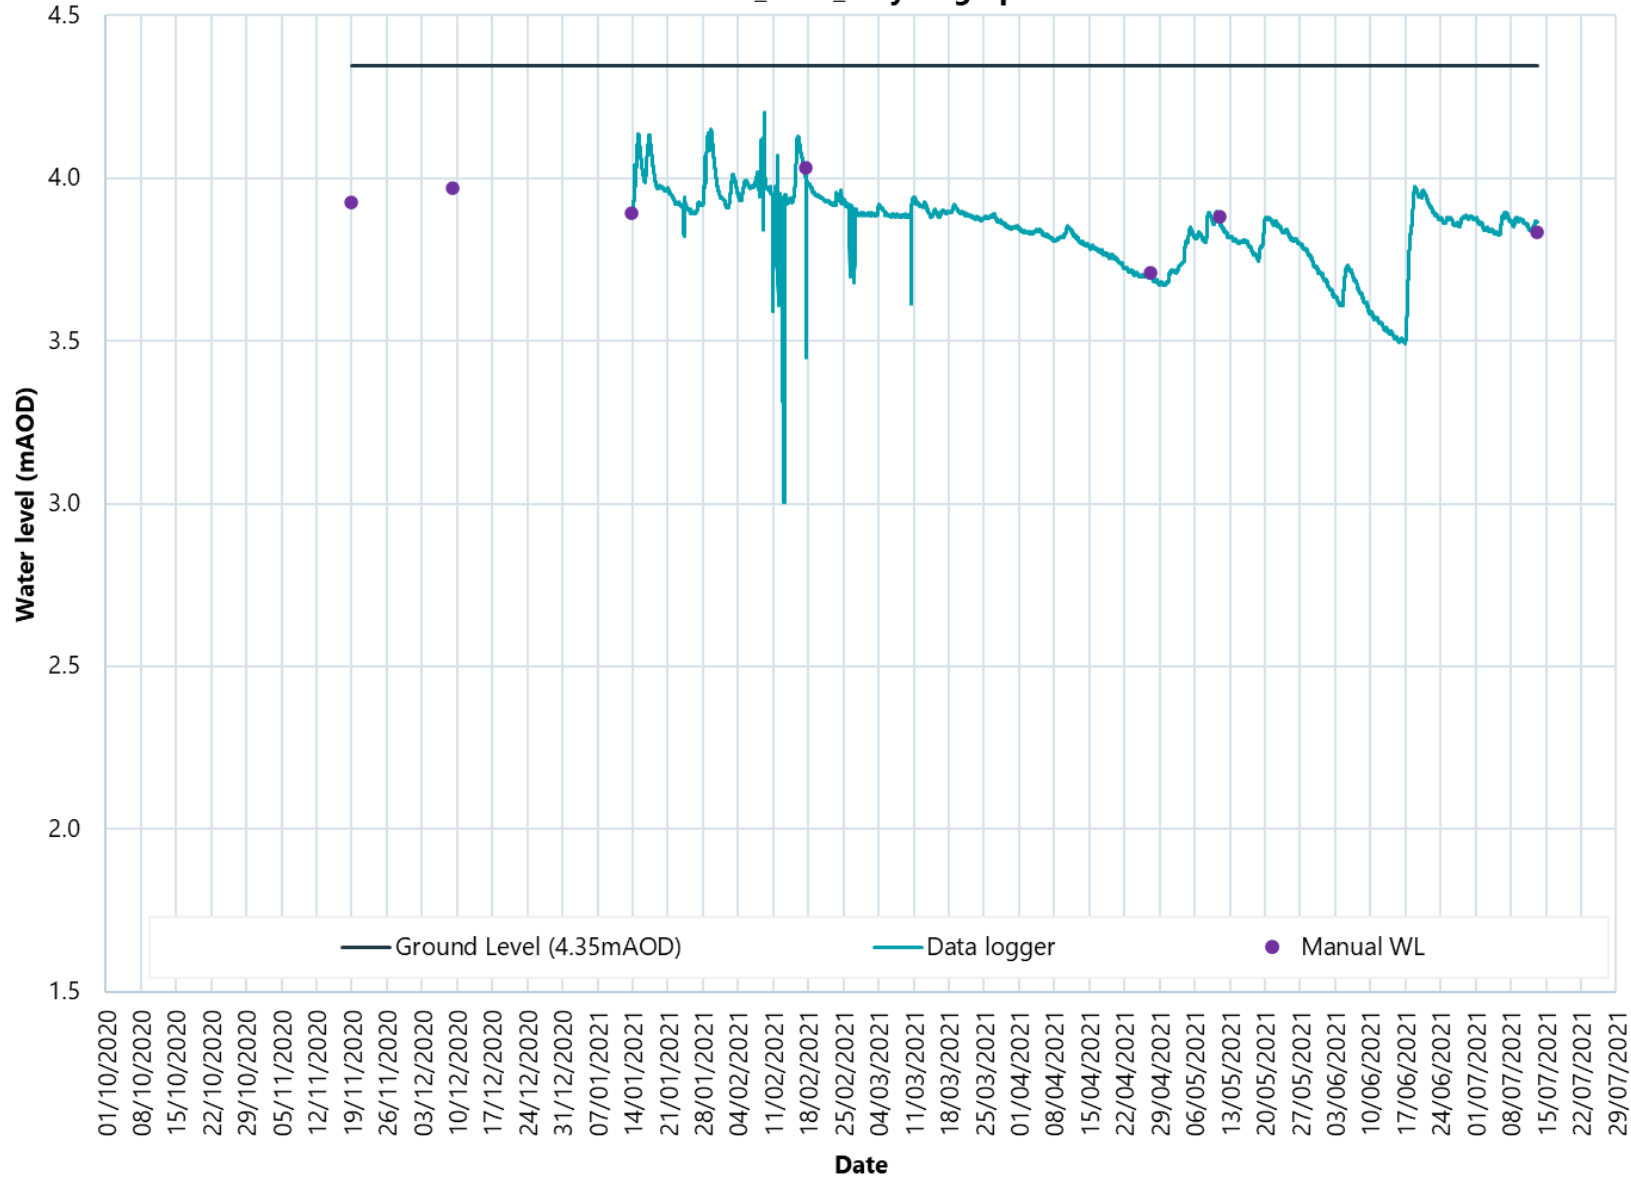
B2

BHALL_1001_s Hydrograph

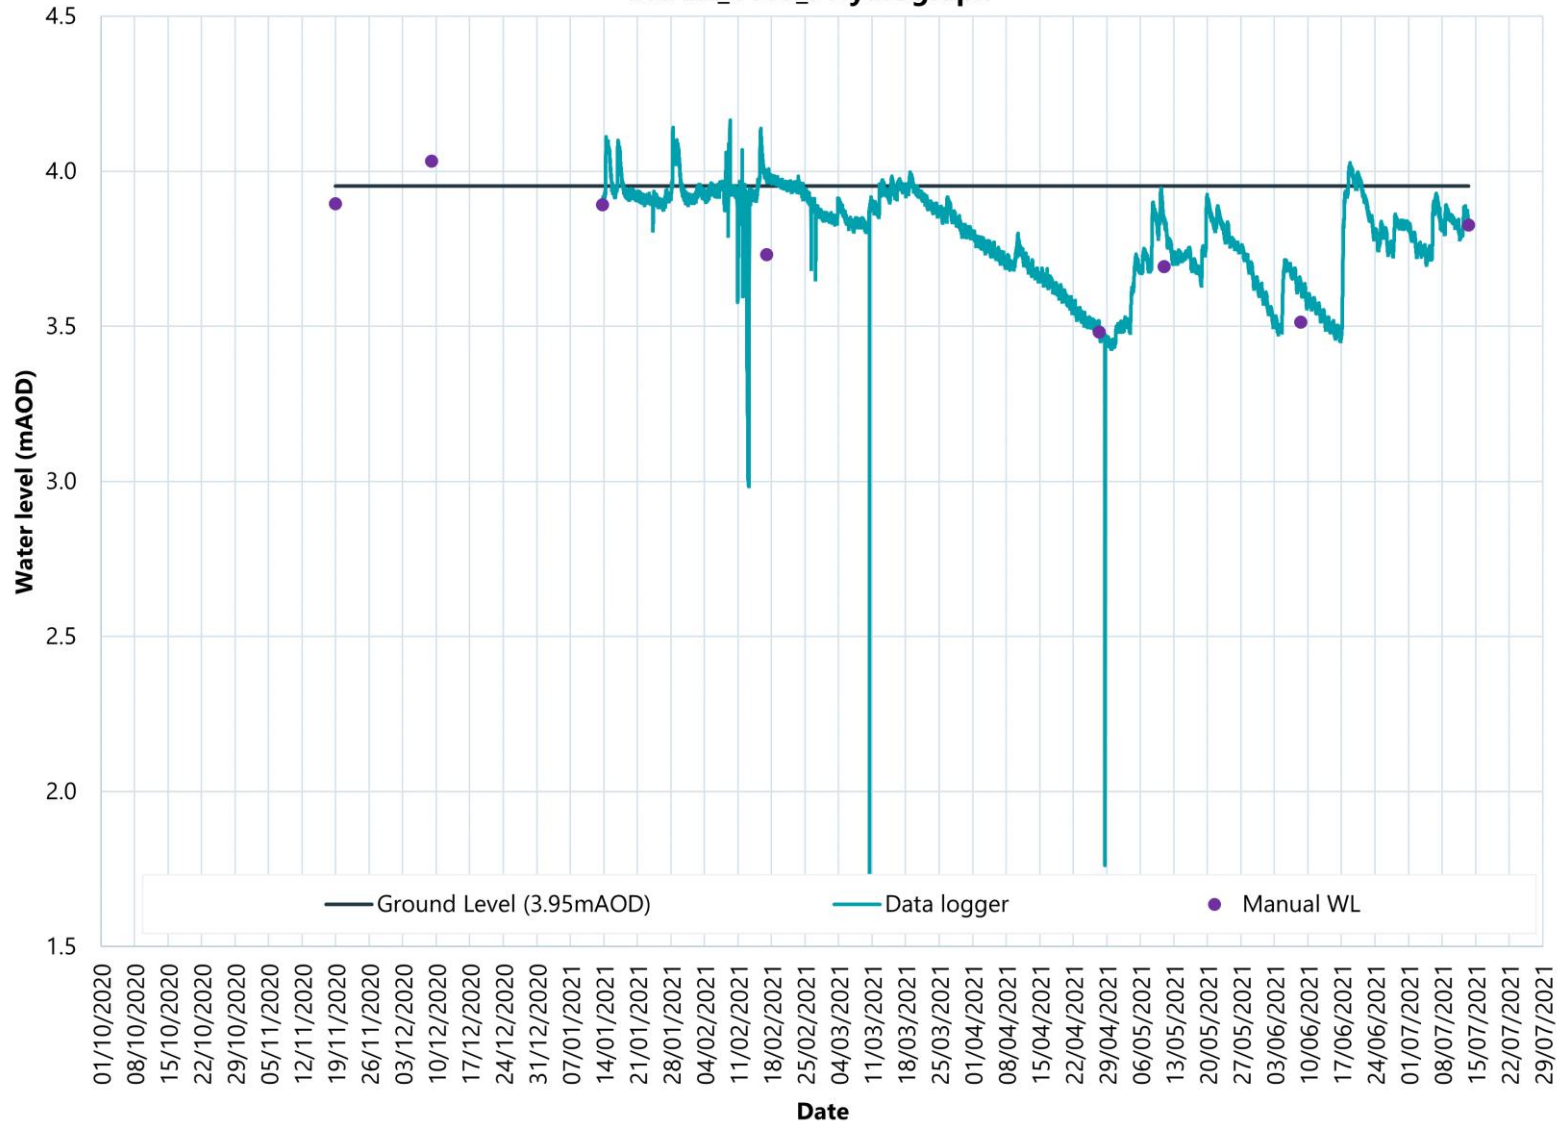
B9

BHALL_1103_s Hydrograph
